# Quality Improvement of Low Pressure Flush Column Reflux Pumps Using PDCA Method: A Case Study in an Urea Plant

This study focuses on the problems in the use and maintenance of centrifugal pumps at PT Pupuk Kalimantan Timur (PKT) in Indonesia. This study specifically looks at the 110-J pump, which is critical to the production process as its failure can result in a shut down of the factory. The study analyzes the history card of the pump over the period of 2015 to 2021 and identifies that there have been multiple repairs due to high vibration, shaft bending, and other internal damage caused by differences in throat bushing sizes. The study calculates that the average loss due to these issues is around IDR 122,012,857 annually and the repair work takes on average about 5 working days. The study uses quality improvement tools plan, do, check, action (PDCA) identify the problems and formulate improvement efforts to increase the usage period and reduce maintenance costs. This study is important for improving the reliability of the production process and ensuring the availability of urea and NPK fertilizer, particularly in Indonesia. Result of this research is the decrease in the freq

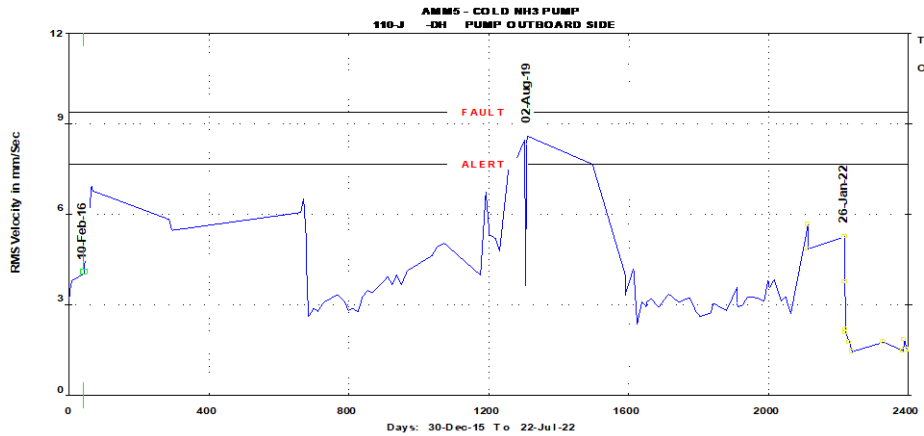
Figure 4. Vibration trend Pump 110-J

Based on the ISO 10816-2 standard, the vibration for a 52 kW pump in the "good" category is a maximum of 2.3 mm/s rms. Figure 4 shows high variation of the vibration and the value is higher than

standard. The graph displays vibrations reaching up to 8 mm/s, indicating unsafe operating conditions that pose a danger to both the equipment and individuals in proximity.

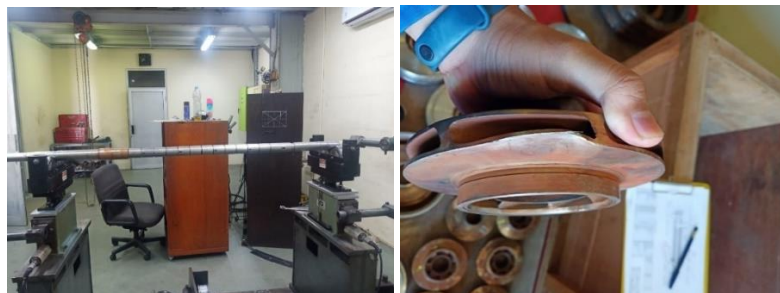
Figure 6. Pump shaft was bending and the wearing ring and impeller were rubbing

Due to high variation of the vibration and the value is higher than standard, during the overhaul, it was found that the pump shaft was bending and the wearing ring and impeller were rubbing.

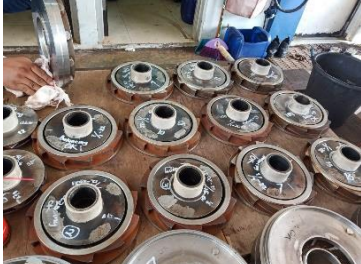
No.	Repair Step	Activity	
1	Inspection, repair and replacement of throat bushing material to PEEK material and uniform size

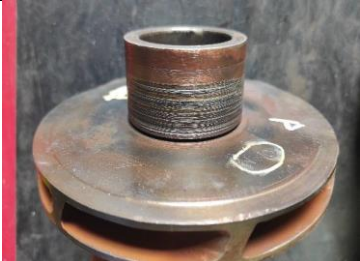
<p>The impeller in the throat bushing area is worn and without PEEK.</p>

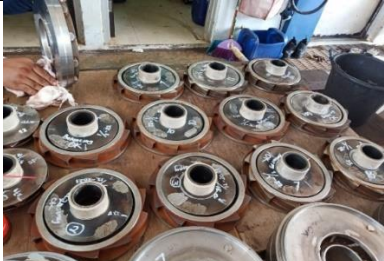
<p>Throat bushing with PEEK material and uniform size.</p>
2

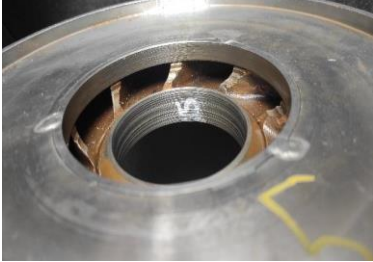
<p>Impeller in the throat bushing area and wearing ring wear.</p>

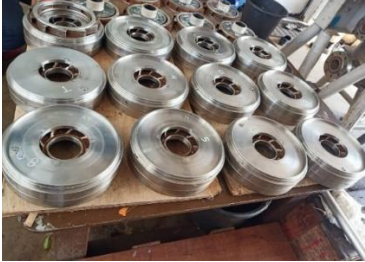
<p>Impeller in the throat bushing area and wearing ring with uniform size.</p>

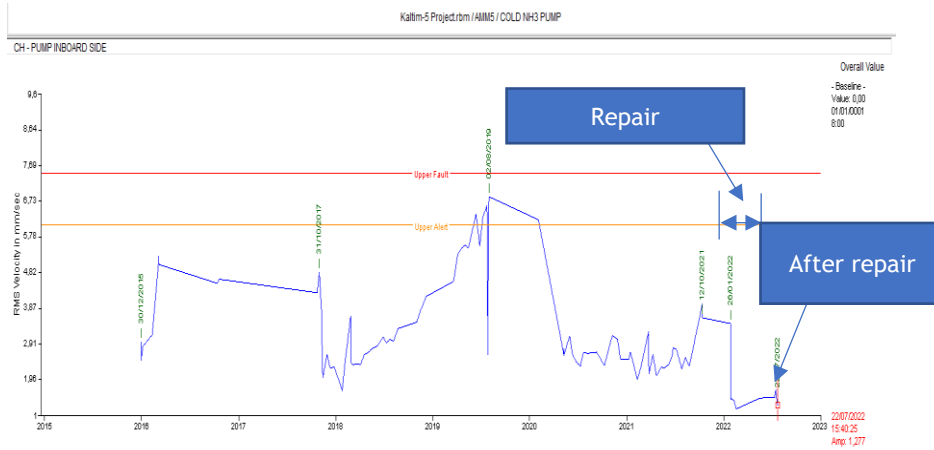
Figure 9. Vibration trend Pump 110-J after repair.

Vibration trending has decreased significantly after repairs. The RMS Velocity after repair below the ISO 10816-2 standard, maximum of 2.3 mm/s rms. This repair has succeeded in overcoming the high-vibration problems and can reduce the risk of damage with low-vibration parameters.
